**Quarry Park Watershed Assessment and
Erosion Prevention Planning Project
San Mateo County, California**

PWA Report No. 181028503
April 2018

APPENDIX B | WATERSHED ASSESSMENT AND EROSION PREVENTION PLAN

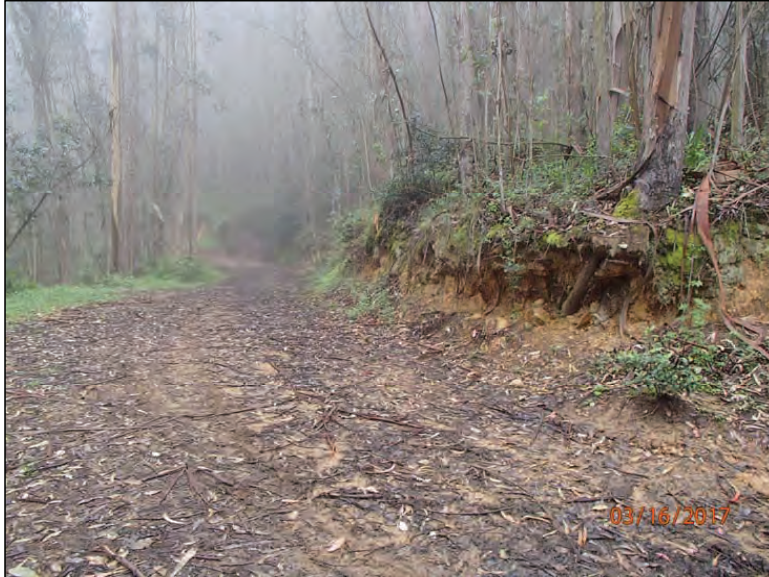
Photo 1 (Dolphine Fire Road): View of the existing road conditions of the native surfaced Dolphine Fire Road near the road intersection with the Middle Ridge Fire Road.

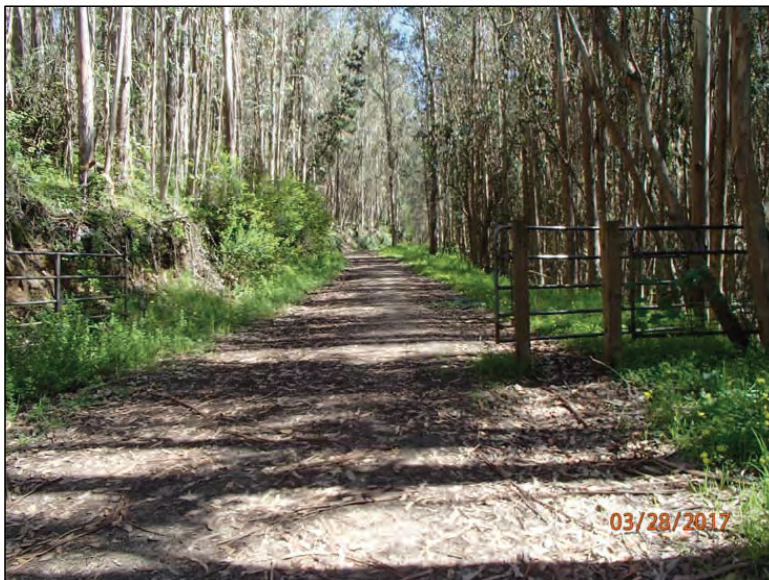
Photo 2 (Miranda East Fire Road): View of the existing road conditions on the Miranda East Fire Road at Gate 4 as shown on Map 2.

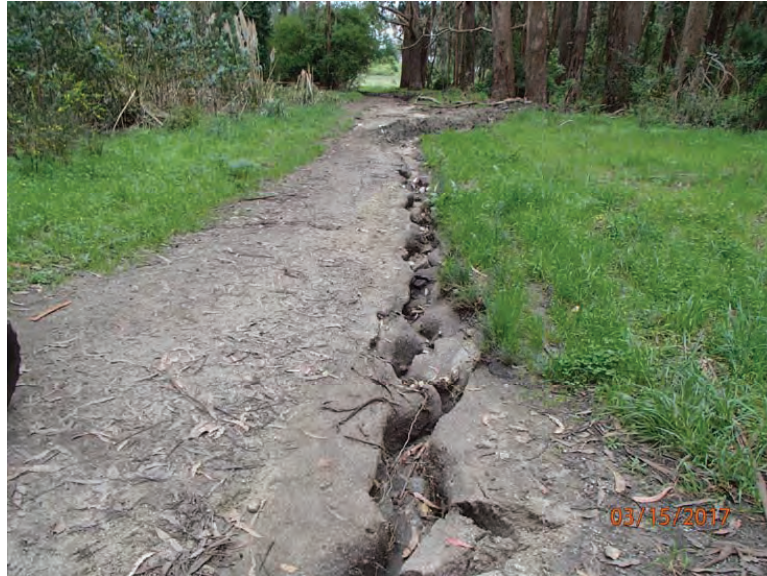
Photo 3 (Meadow Trail): View of active gully erosion along the Meadow trail. Combined diverted stream flow and concentrated road runoff are eroding the road surface along this native surfaced road.

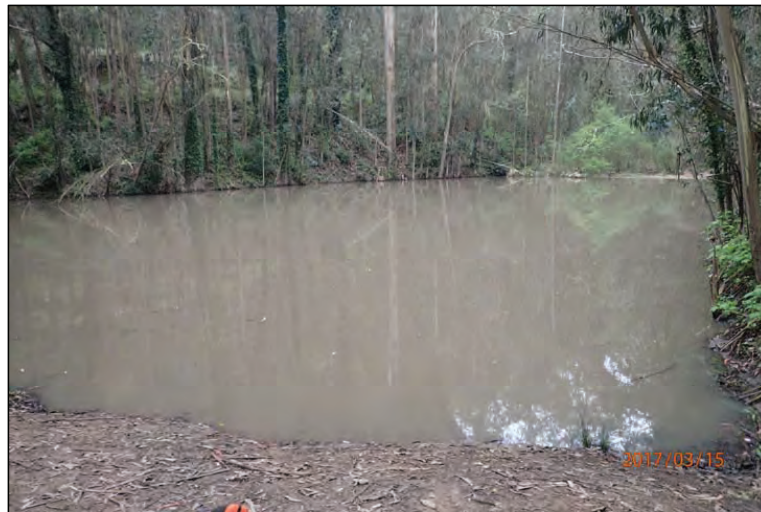
Photo 4 (Site #4): View of the on-stream pond located at Site #4 looking upstream from the left edge of the levee. Note the aggraded sediment at the upstream edge of the pond.

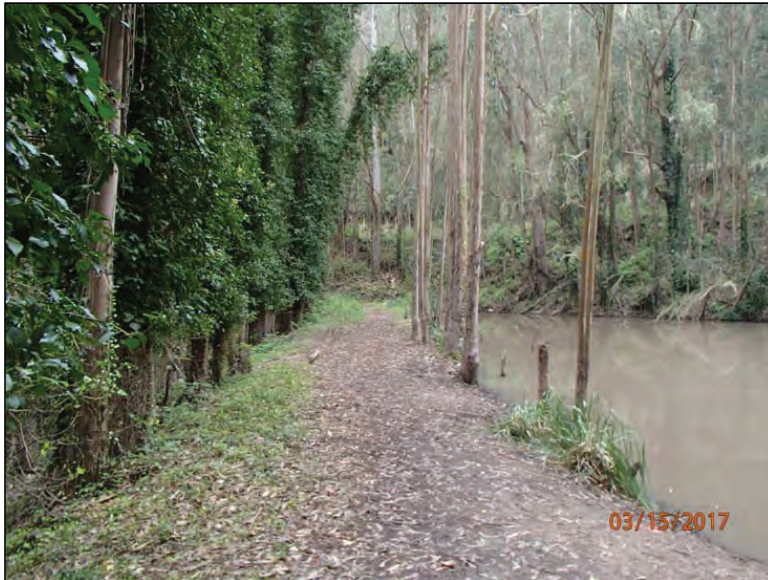
Photo 5 (Site #4): View of the levee associated with the on-stream reservoir Site #4, looking west-southwest across the top of the dam face.

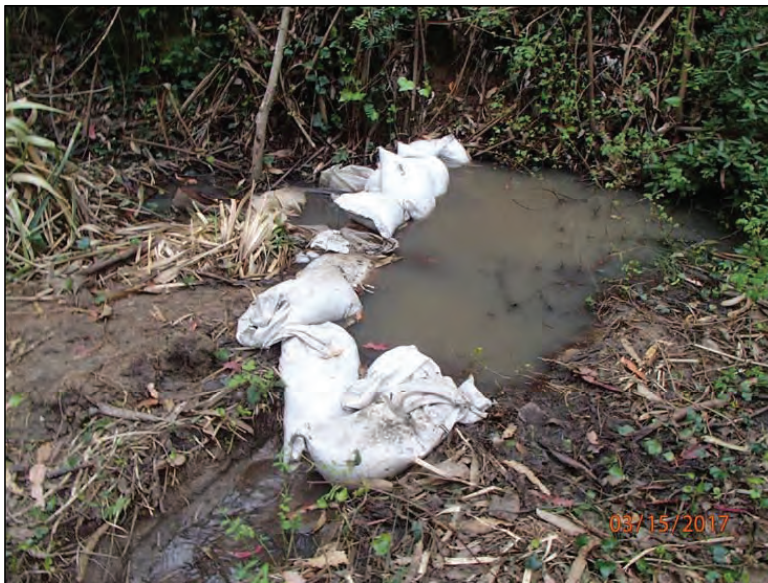
Photo 6 (Site #4): View of temporary dysfunctional sandbag spillway at the southwest corner of the on-stream pond Site #4.

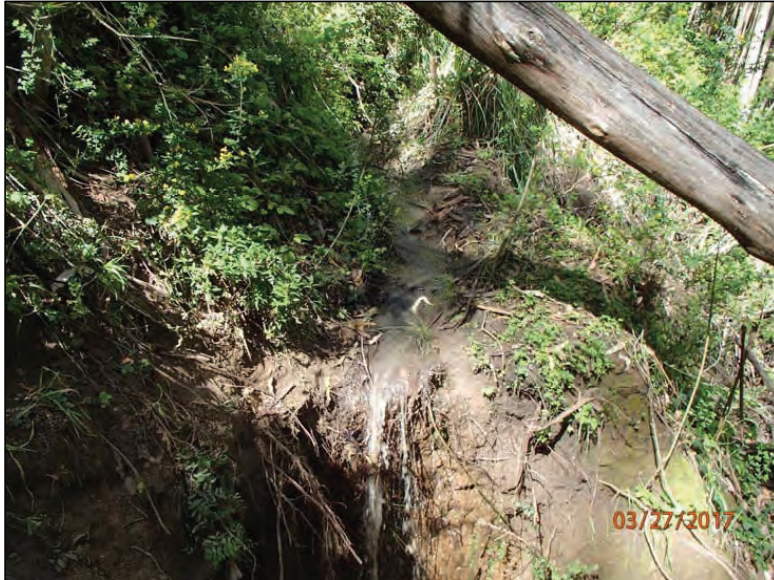
Photo 7 (Site #4): View of a road fill failure caused by diverted pond outflow. This erosion feature is located down the right road from the levee. Note the road prism is completely washed out.

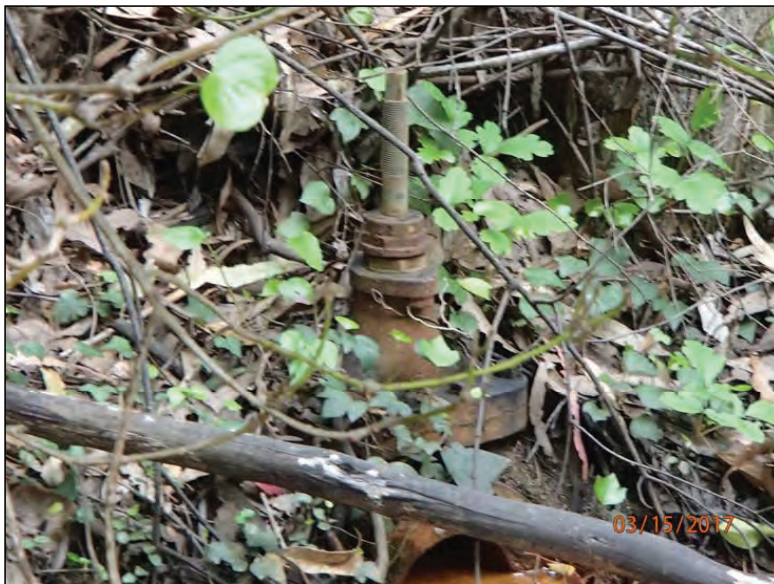
Photo 8 (Site #4): View of the seeping drainage valve at base of the dam fillslope in the axis of the valley downstream of pond.

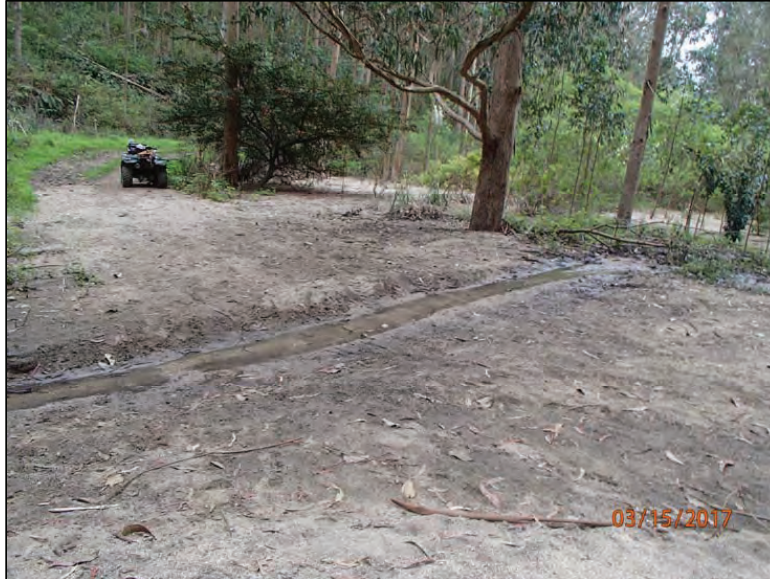
Photo 9 (Site #2): View of stream crossing through this shallow sediment filled pond. Stream sediment transport has deposited a large volume of fine sediment in this old pond, inundating the pond and trail.

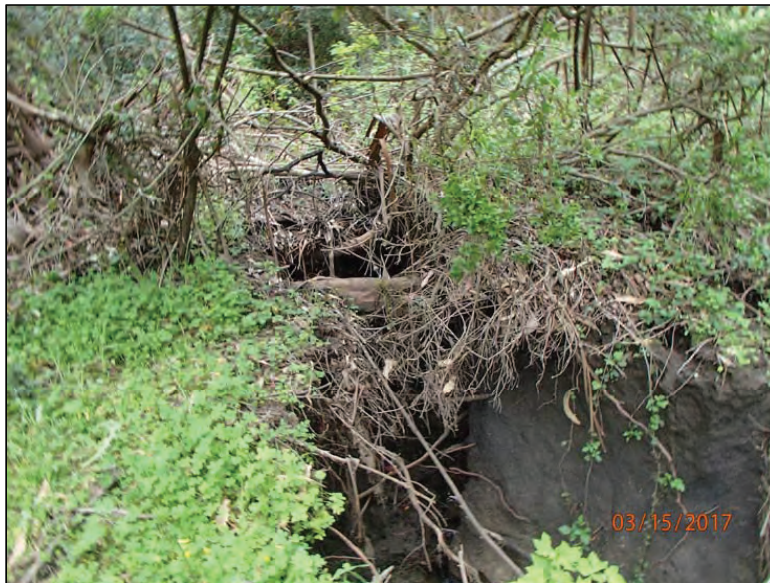
Photo 10 (Site #2): View of an active 5.5ft tall headcut at the downstream extent of the inundated pond at stream crossing Site #2 on the Meadow trail shown in the previous photo.

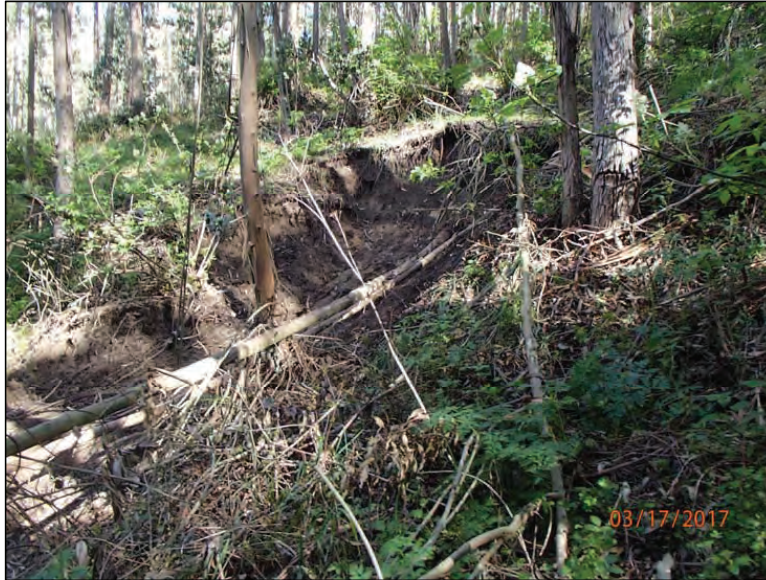
Photo 11 (Site #19): View of failing cutbank immediately upslope of the right edge of stream crossing Site #19. This cutbank failure delivers directly to the Class III stream in the axis of the crossing fill crossing.

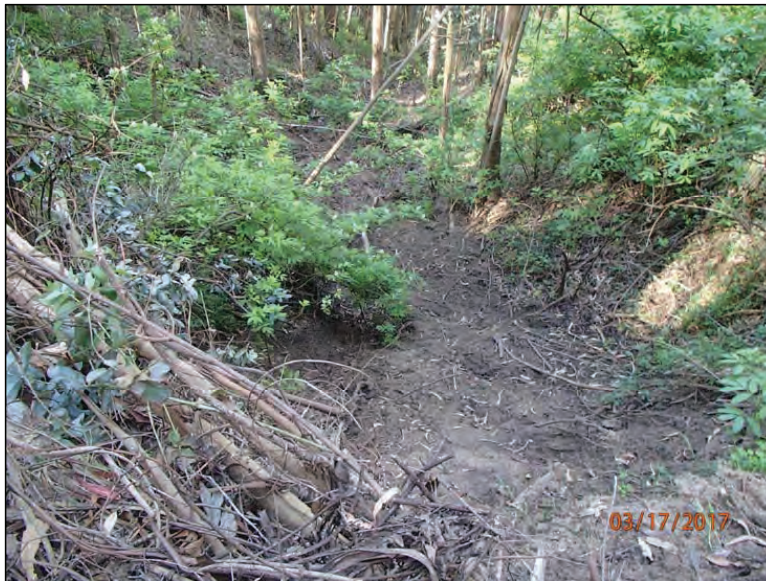
Photo 12 (Site #19): View of failing outboard fillslope, looking downslope at the fill failure deposits below the right hingeline of the fill crossing at Site #19. This photo was taken from the outboard edge of the road.

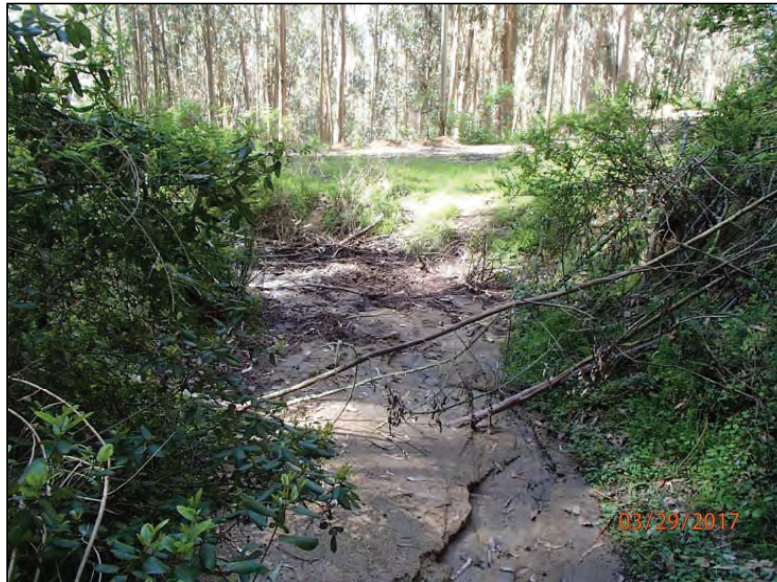
Photo 13 (Site #39): View looking downstream from the upstream extent of the of the failing stream crossing. Note the recently deposited sediments that have plugged the culvert inlets. The sediment is causing the stream flow to divert down the left road which is inducing a delivering fill failure.

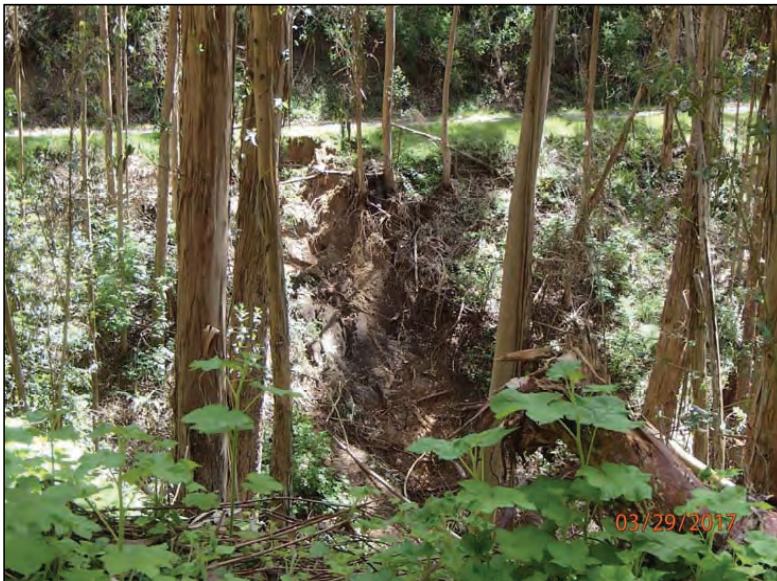
Photo 14 (Site #39): View of an outboard fill failure to the left of the stream crossing. The fill failure was induced by the diverted streamflow from the plugged stream crossing at Site #39 and excessive concentrated road surface runoff.

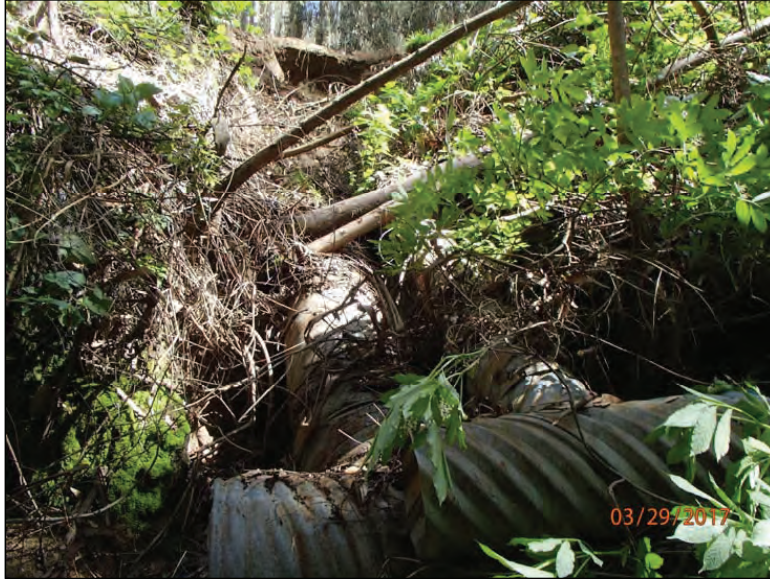
Photo 15 (Site #39): View looking upstream at the failing outboard fillslope of this plugged stream crossing. The photo was taken standing approximately 8ft downstream of the culvert outlets.

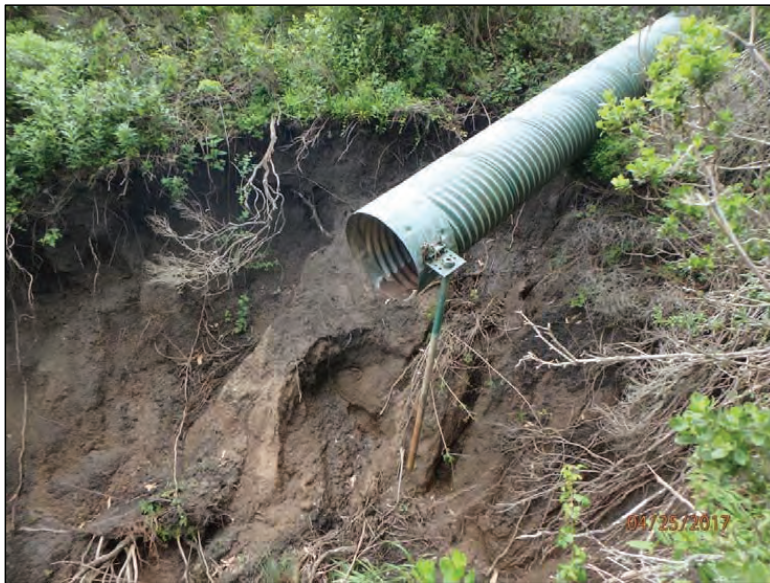
Photo 16 (Site #40): View of a section of disconnected culvert downspout at the top of an actively migrating headcut and gully below the paved Private Drive at Site #40. Oxidation exposed on the stake is indicative of the previous depth of burial prior to the episodic hillslope failure.

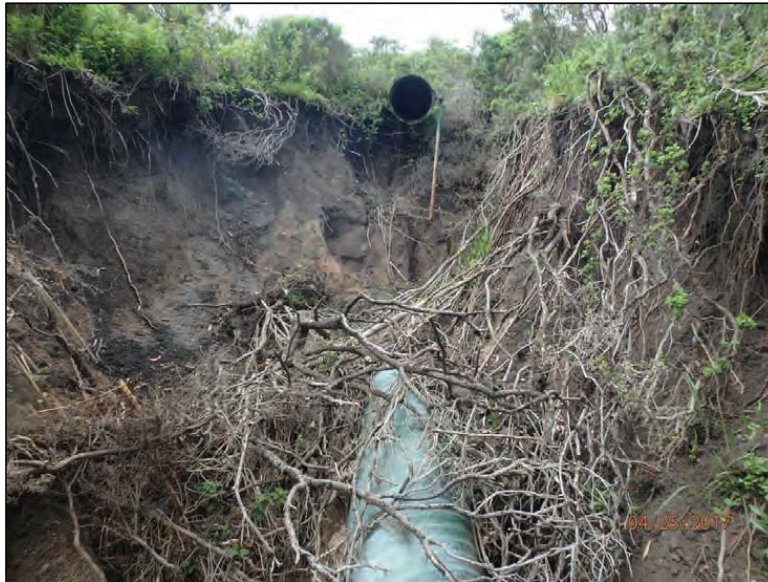
Photo 17 (Site #40): View looking upslope at the same disconnected downslope and active erosion as shown in the previous photo. The photo was taken from the base of the gully downslope of the headcut standing on top of one of the failed sections of culvert.

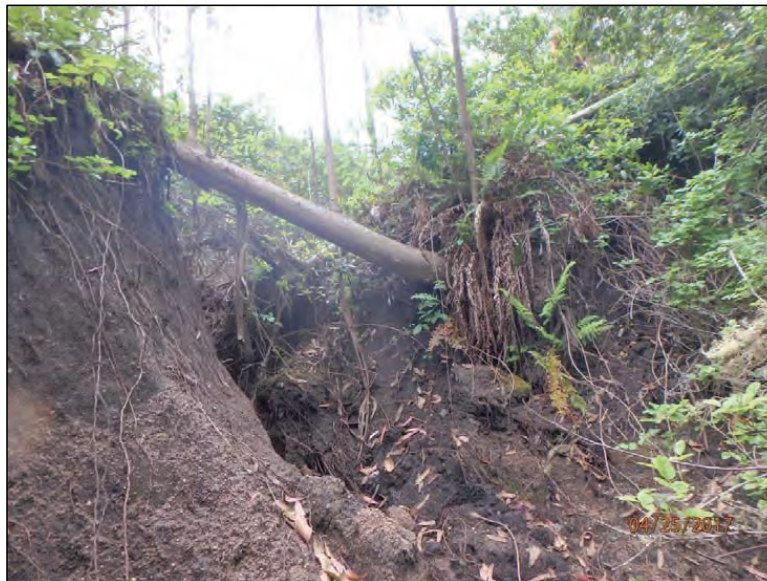
Photo 18 (Site #40): View of active hillslope gully below Site #40 looking upstream. This photo was taken from the edge of the tree-line near the headwaters of a small Class III stream that drains to Site #16 downstream. The gully is conveying sediment from the gully erosion upslope to the Class III stream.

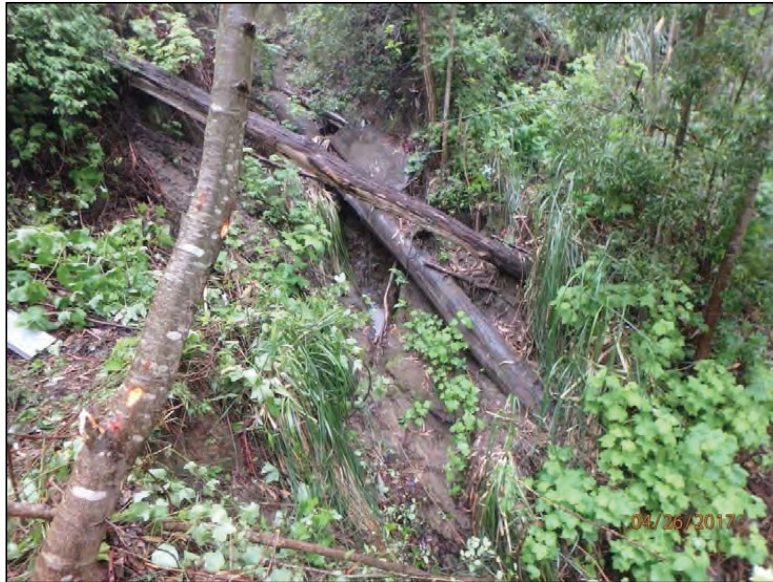
Photo 19 (Site #41): View looking upstream at a washed out fill crossing on a near origin Class III stream downslope from residential area on Santa Maria Avenue. This view of the scoured stream channel was taken from the outboard edge of road at Site #41.

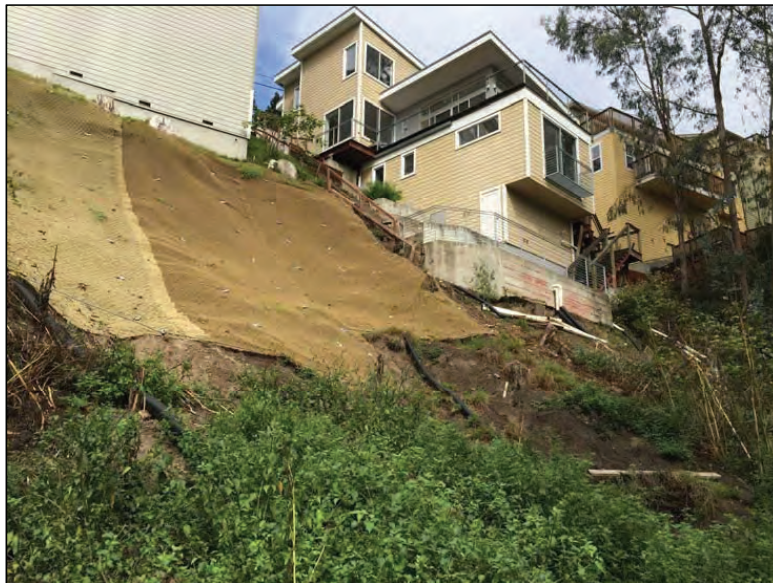
Photo 20 (Site #41): View of a hillslope failure and undermined residences upstream from Site #41. This area upslope extent of AOC 4 as discussed in the text of the report. This photo was taken from the outboard edge of the Fire Break Road upslope from the Upper Pond Legacy Road as shown on Map 2.

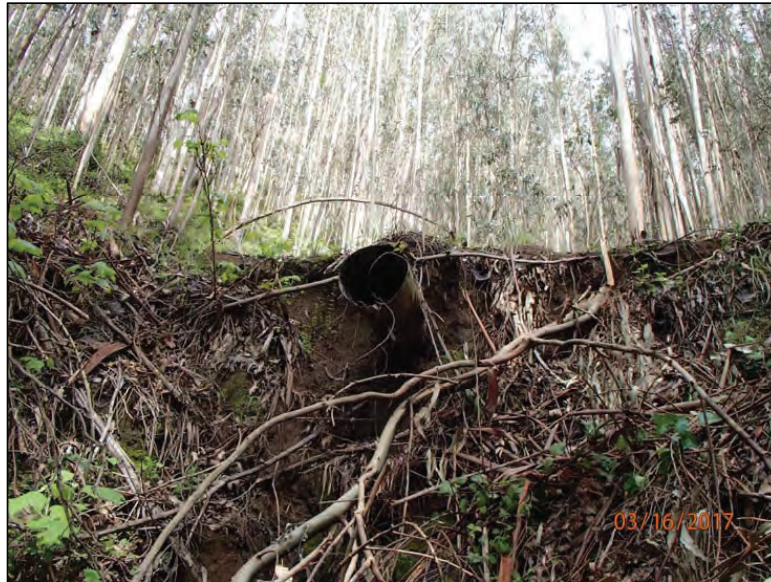
Photo 21 (Site #9): View of the perched culvert outlet at stream crossing Site #9. The culvert at this crossing is undersized and installed high and short in the fill with a 6ft drop at the outlet and subsequent outboard fill erosion.

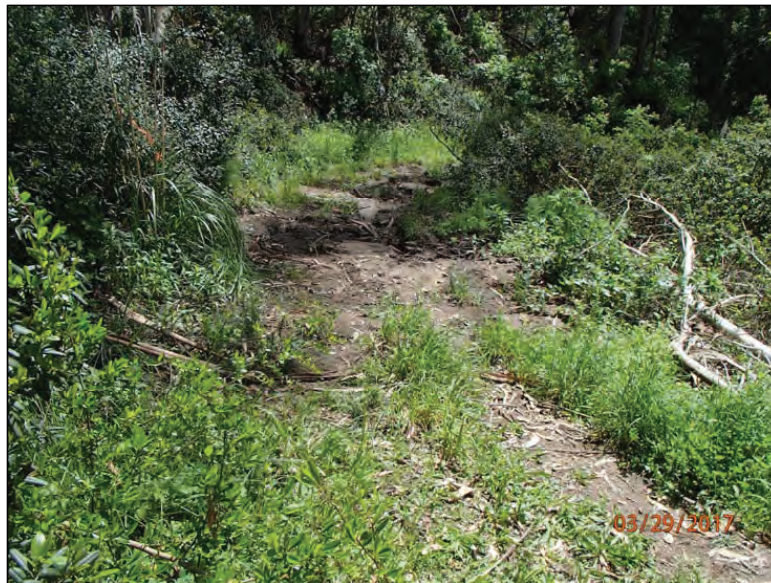
Photo 22 (Site #16): View of the fill crossing at Site #16 on the Dolphine Fire Road. Diverted stream flow is actively eroding gullies down the left road from this stream crossing.

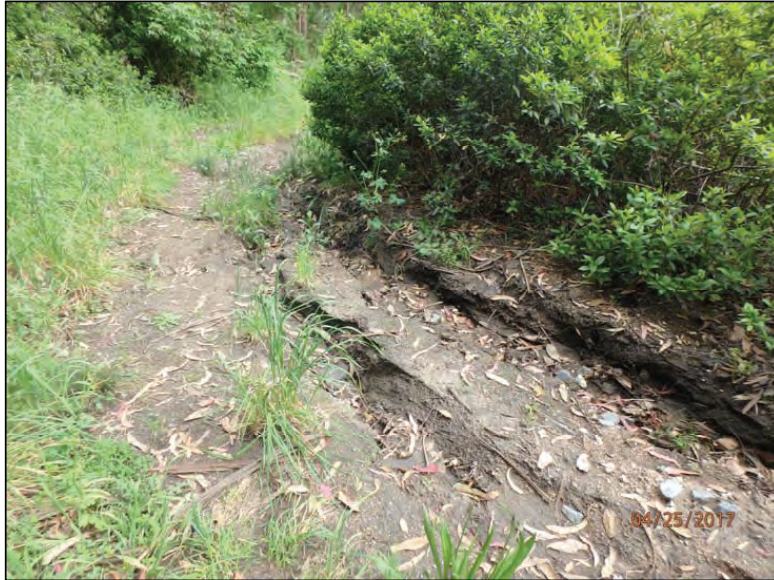
Photo 23 (Site #16): View of the left road approach to fill crossing Site #16. Diverted stream flow is actively eroding gullies down the left road from this stream crossing and delivering to a watercourse at Site #15.

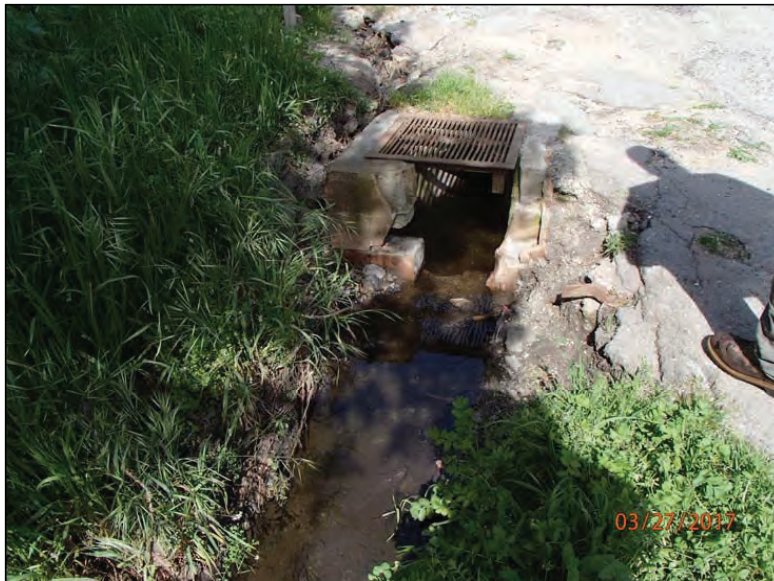
Photo 24 (Site #23): View of the outlet of the culvert at stream crossing Site #23 at the edge of the main parking lot. This culvert is undersized and stream flow avulses out of the drainage alignment and onto the parking lot surface.

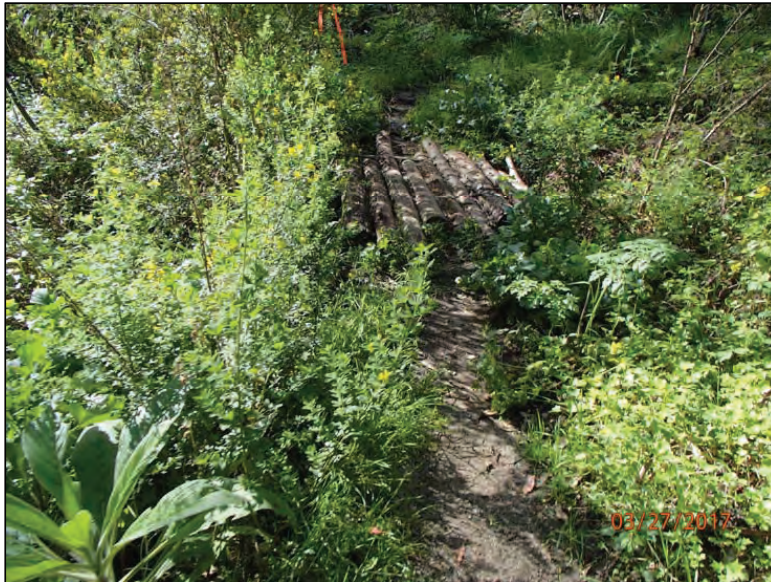
Photo 25 (Site #24): View of a makeshift foot bridge at stream crossing Site #24. The active erosion at this site is minimal, and a formal crossing should be established.

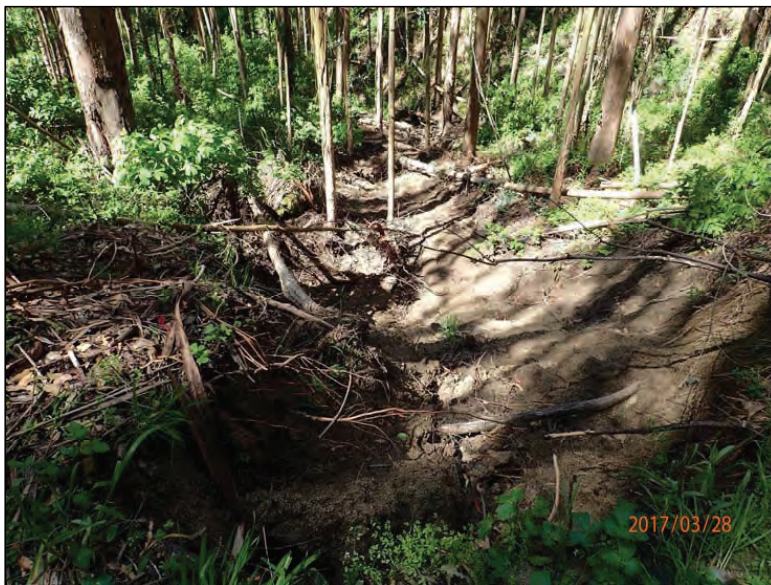
Photo 26 (Site #31): View of an outboard fill failure at Site #31 on the Vista Point Trail. Concentrated road run off had saturated the steep outboard fill and subsequently destabilized the fillslope leading to failure.

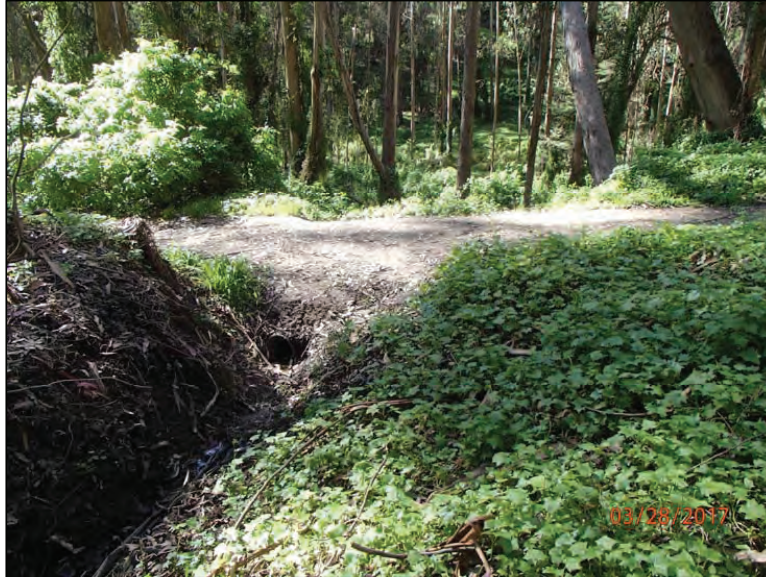
Photo 27 (Site #36): View of a culvert inlet on a small Class III stream at Site #36. This site is downstream of the pond Site #37 in the base of the quarry.

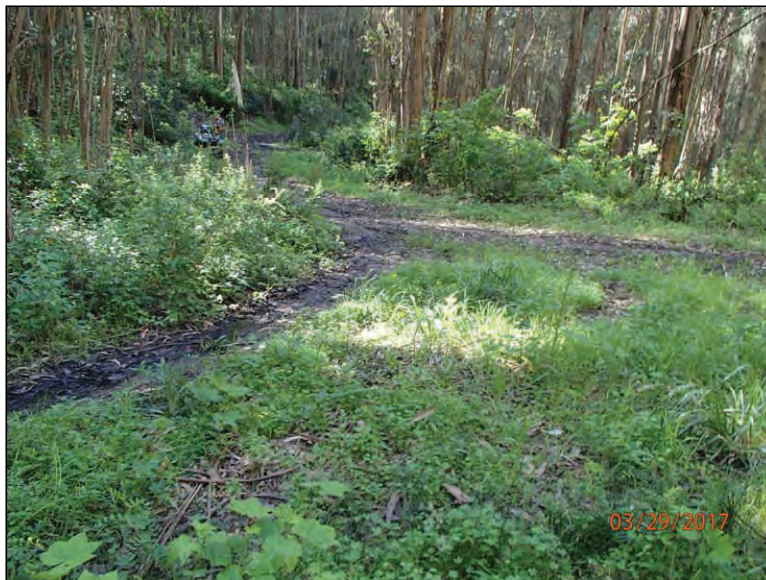
Photo 28 (Site #38): View of the right road approaches to a fill on crossing on a Class III stream on the South Ridge Trail.

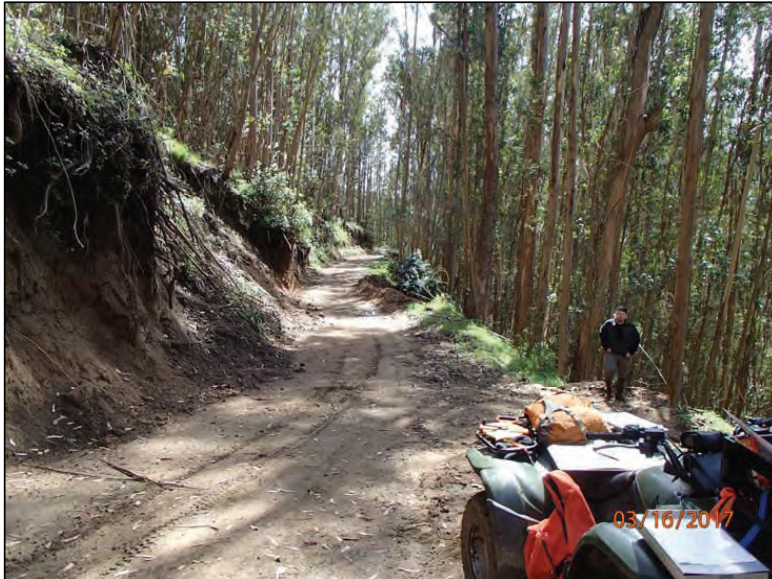
Photo 29 (Site #11): View of the hydrologically connected left road approach to landslide Site #11. Long reaches of concentrated road runoff have eroded a gully down the outboard fillslope and induced a failure.

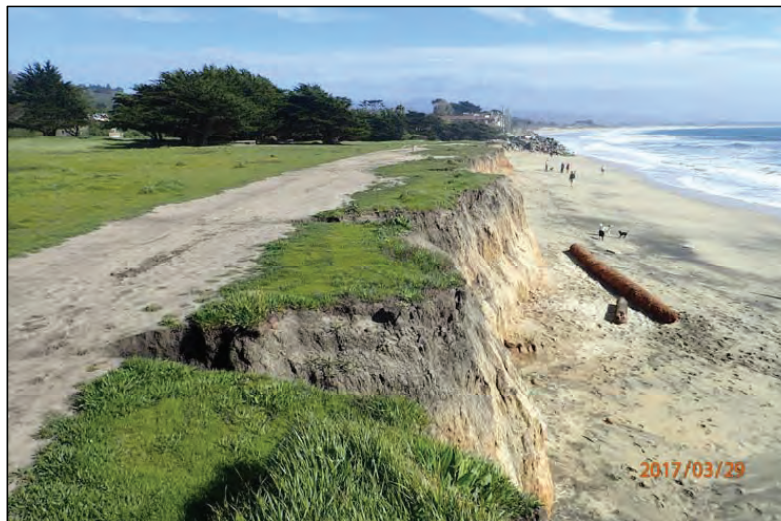
Photo 30 (Coastal Bluff Trail): View of bluff retreat looking south along unpaved coastal trail. The gullies located along the wave cut bluffs are exacerbated by concentrated runoff from the trail and upslope marine terrace meadows.

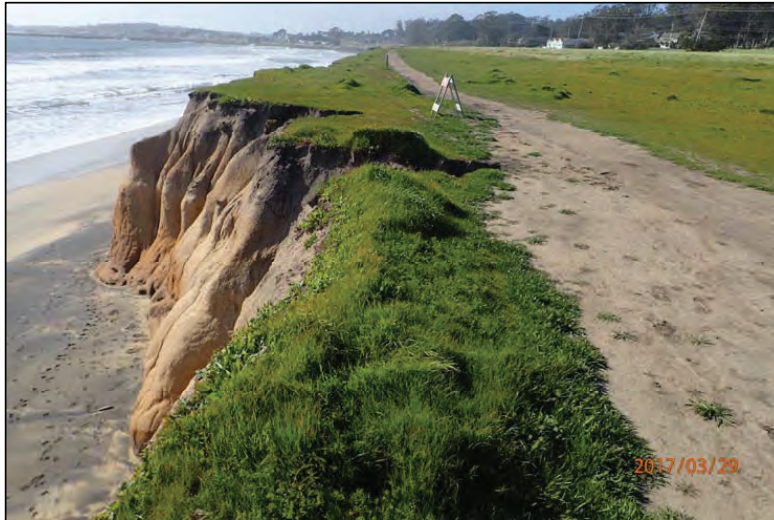
Photo 31 (Coastal Bluff Trail): View of bluff retreat looking northward along unpaved coastal trail. This photo is looking up the hydrologically connected right road reach to the gullies displayed in the previous photo.

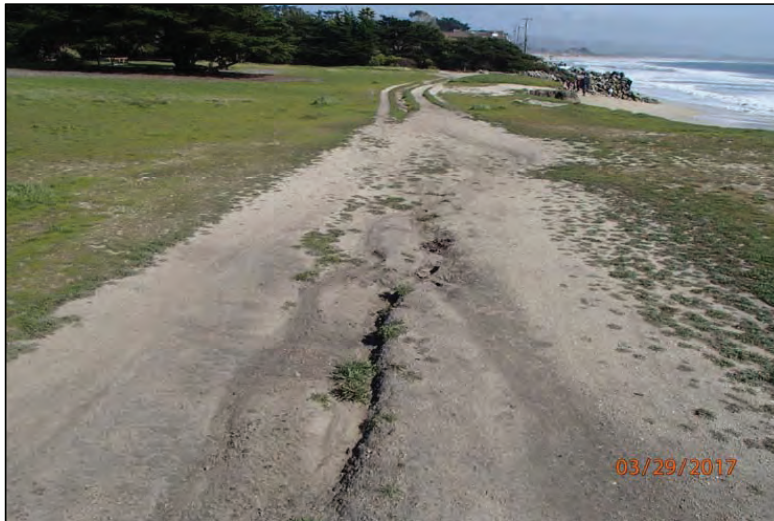
Photo 32 (Coastal Bluff Trail): View of road surface erosion along the coastal trail due to concentrating runoff. Note the exposed beach protection rock armor at the edge of the park boundary in the distance.

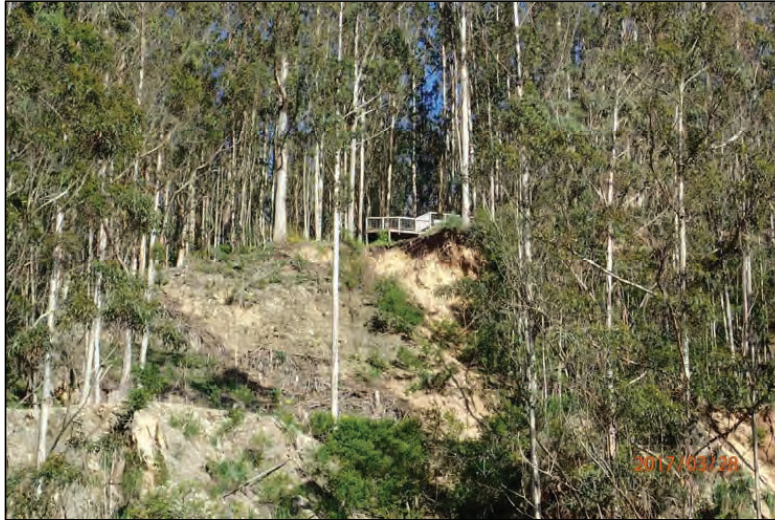
Photo 33 (Lookout Vista): View of the lookout deck and failing hillslope below the outermost footing. This photo was taken looking upslope from the base of the quarry floor.

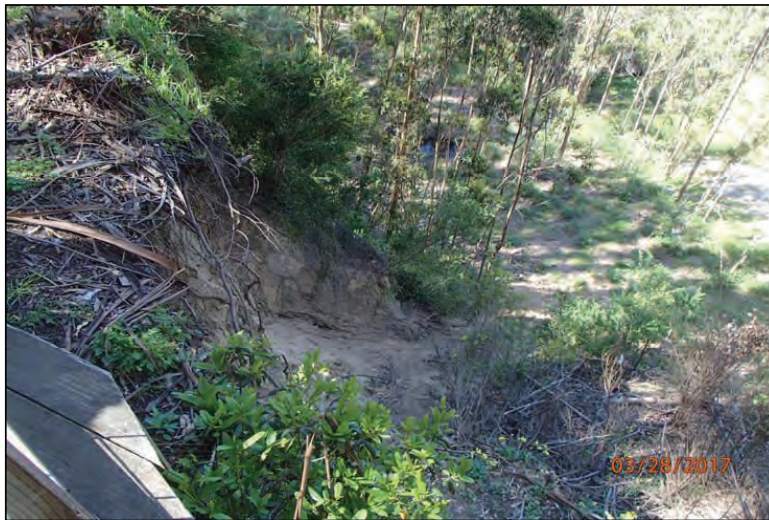
Photo 34 (Lookout Vista): View of the failing hillslope below the wooden lookout vista platform. The quarry cutslope is oversteep and is actively failing in multiple locations along the upper edge of the quarry area.

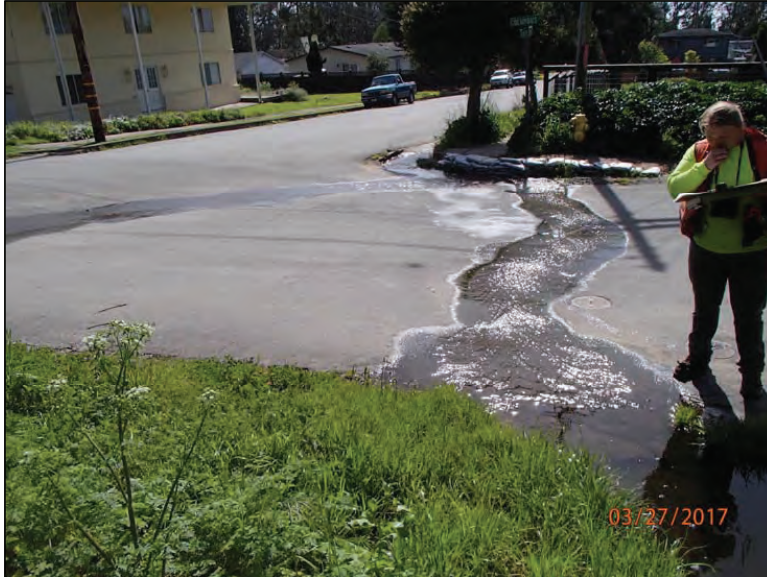
Photo 35 (Urban Drainage Interface - AOC 2): View of uncontrolled Class II stream flow exiting the Park at Santa Maria Avenue (AOC2, Map 2). Combined flow from the stream and road surface runoff travel down Santa Maria Ave. The majority of the Park's drainage area evacuates the Property into the residential area downstream at this location.

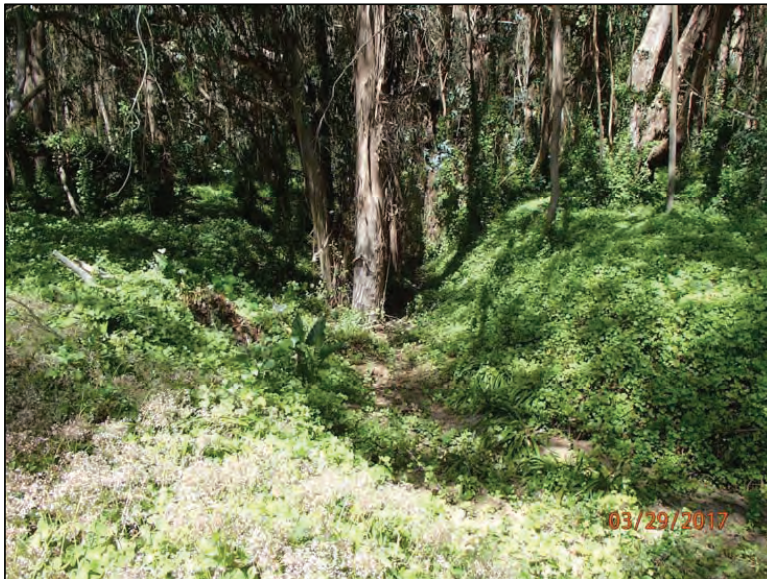
Photo 36 (Urban Drainage Interface - AOC 3): View of a seasonal Class II stream channel downstream from Site #39, ~30 ft upstream from an uncontrolled urban drainage interface (AOC 3) at Moro Drive on the south western boundary of the Park (AOC3, Map 2).

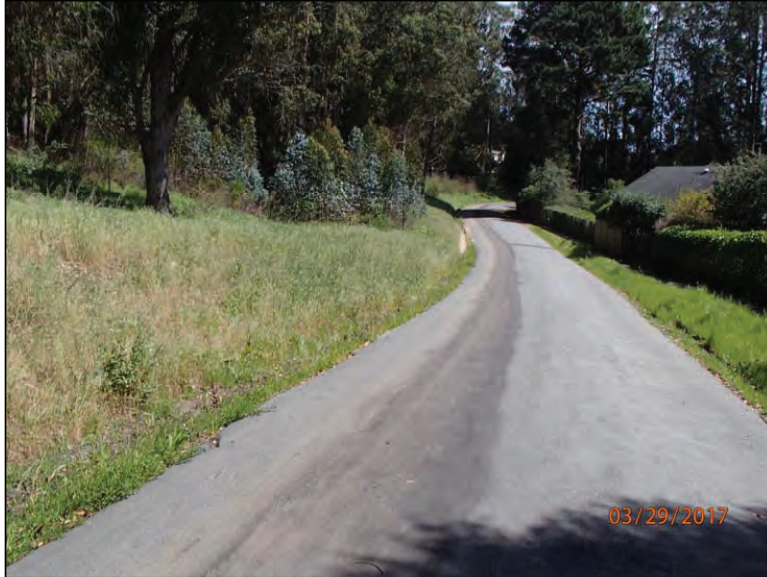
Photo 37 (Urban Drainage Interface – AOC 3): View of the urban drainage interface located on Moro Ave, (AOC 3, Map 2). Flow is conveyed down the inboard ditch for ~325' to a ditch relief culvert at the intersection of Santiago Ave. and Moro Ave. The crowned road surface keeps the majority of the stream flow on the inboard edge of the road.
