Vegetation Management in Caltrans Highway 1 right-of-way in Montara

Midcoast Community Council

March 14, 2018

Caltrans Hwy 1 vegetation maintenance in Montara

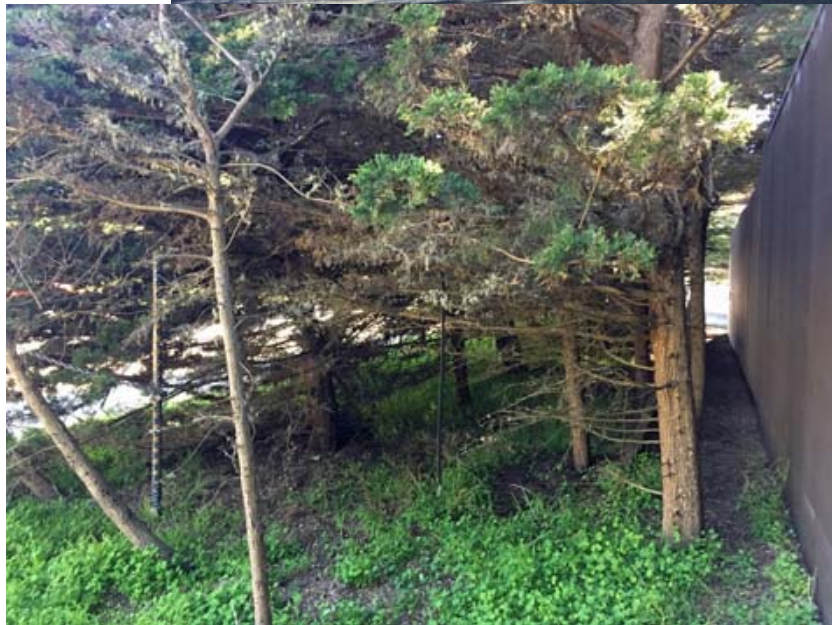
5th to Seacliff (6th)

Dense cypress tree planting in front of tall masonry wall is encroaching into the Caltrans gravel shoulder.

Prune off lower branches at trunks for long-term solution to keeping the wide shoulder clear for pedestrians.

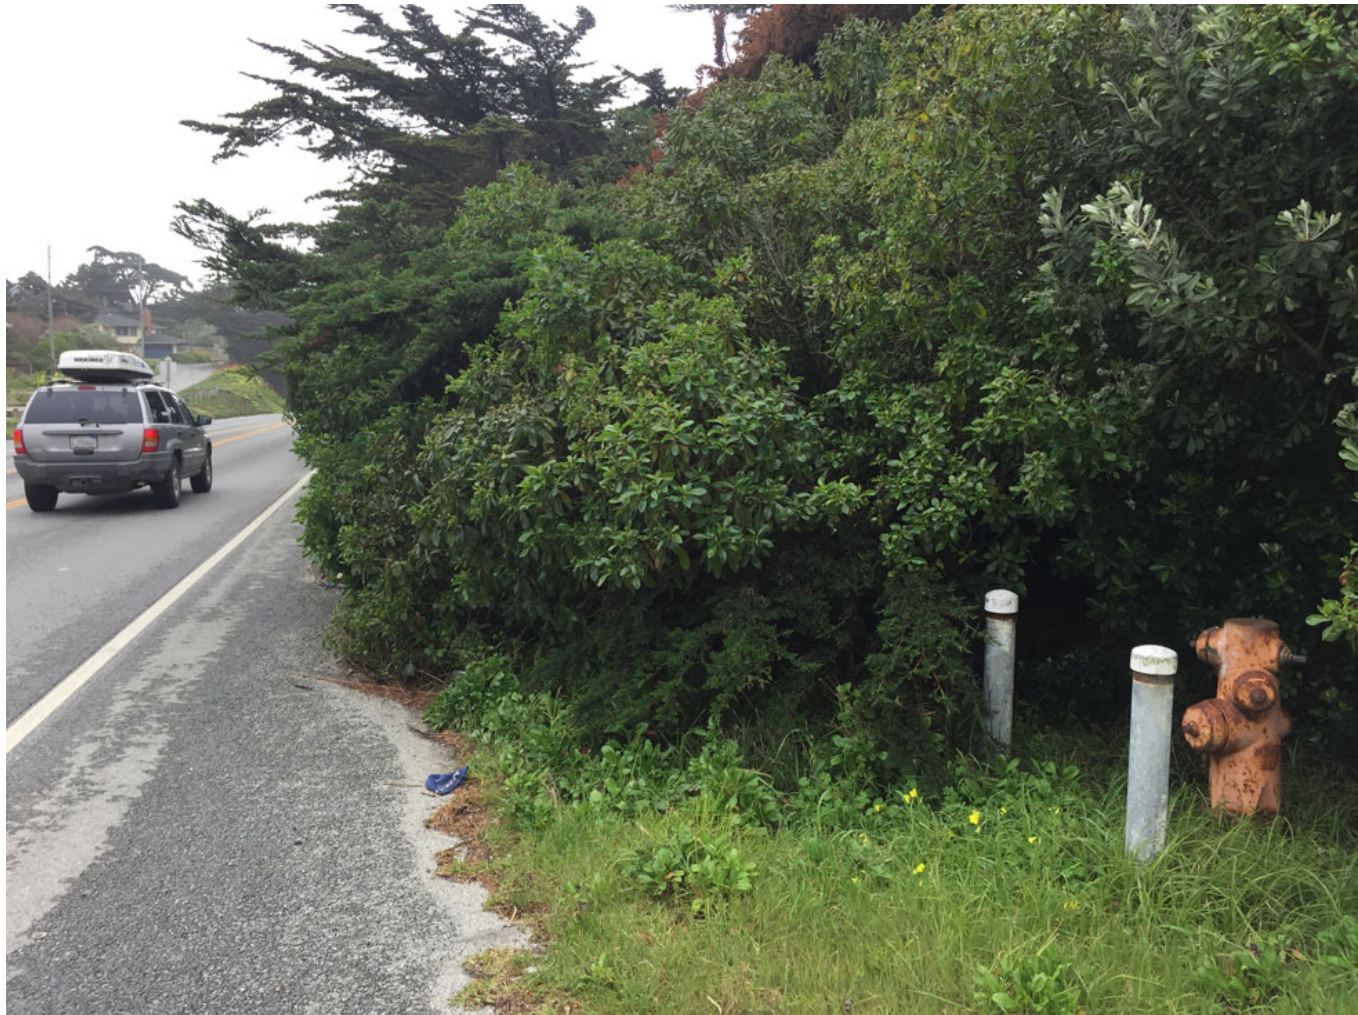
Just south of 9th

- Prune cypress branches back to trunks.
- Prune back & maintain shrubs even with fire hydrant -- makes level unpaved shoulder area available for pedestrians, fire truck, and driveway sight distance.
- See next slide for maintenance history at this location.

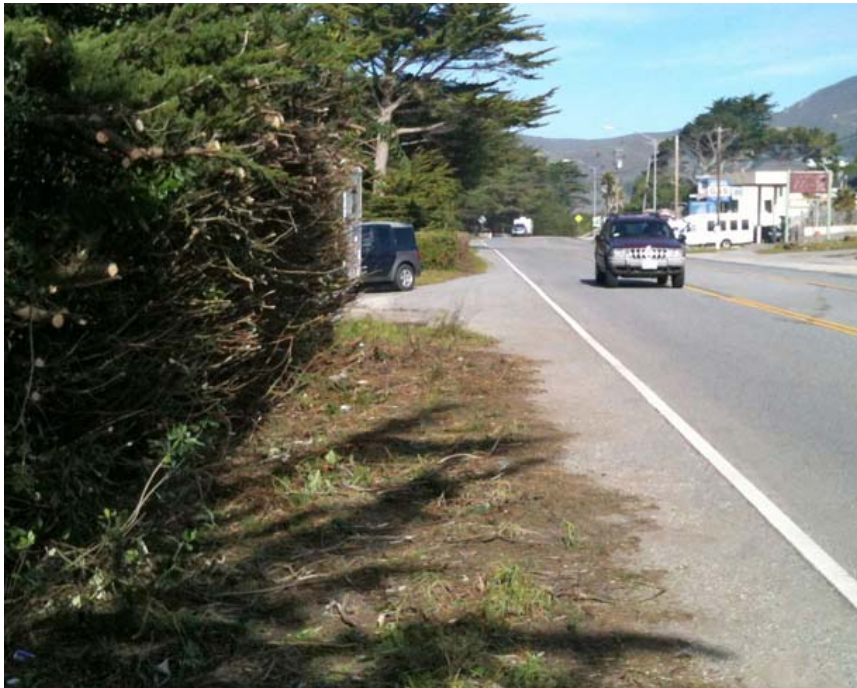
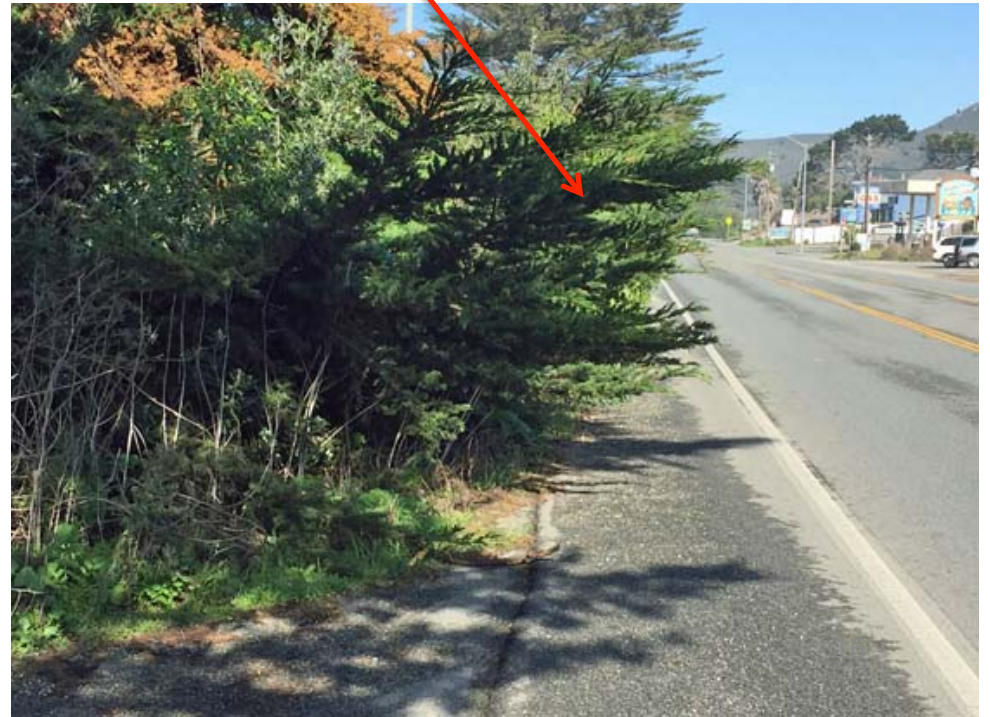
10th St. maintenance

Remove 3 small dead staked cypress trees from view corridor.

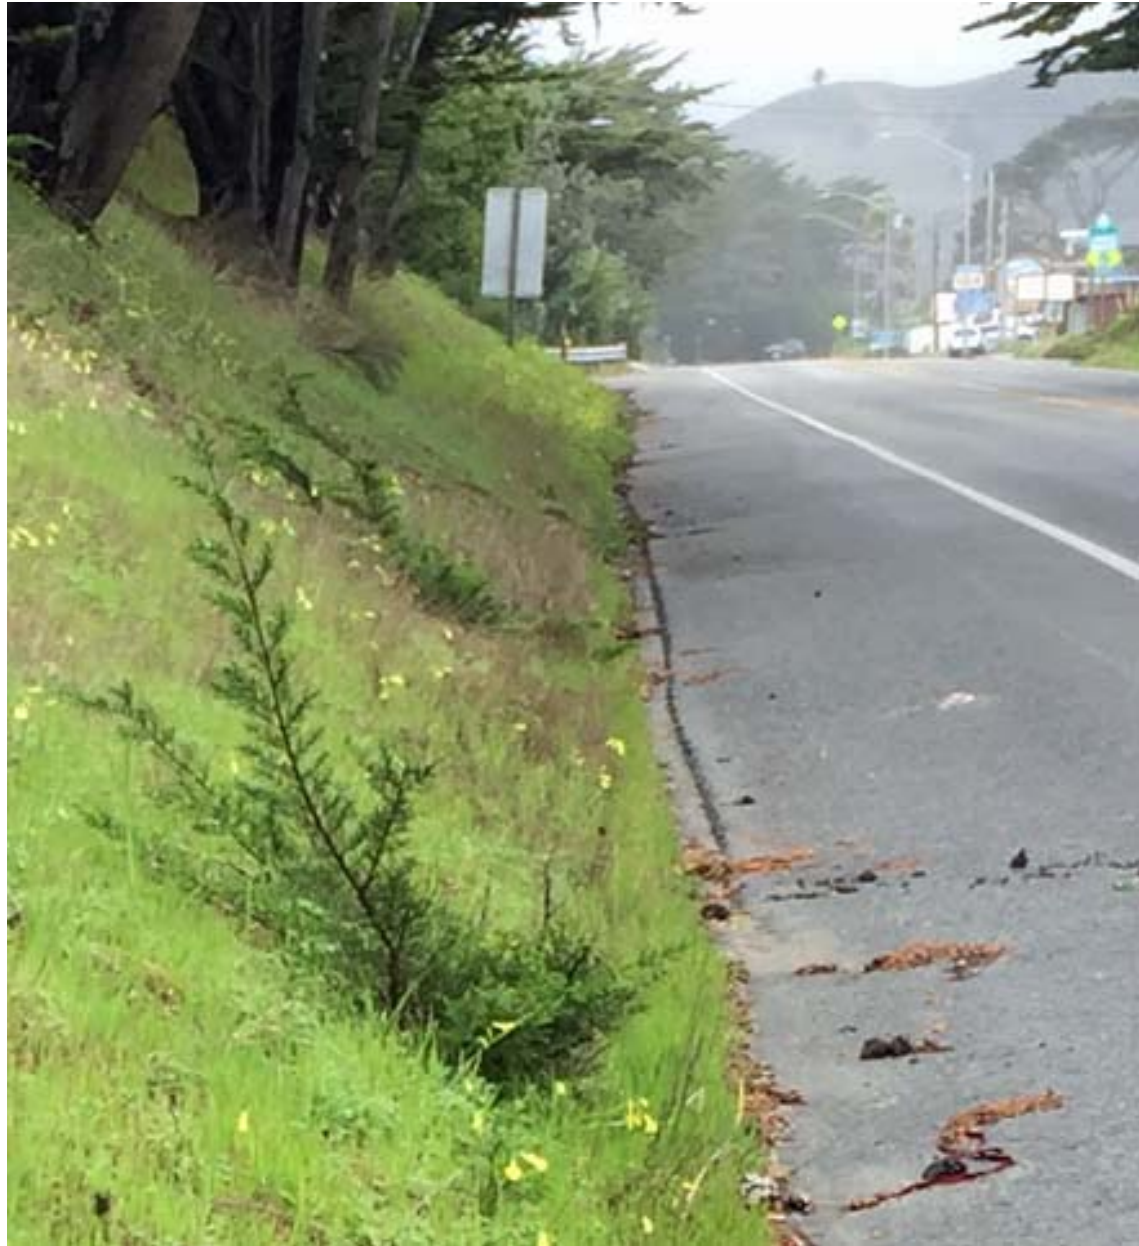
11th to 12th

Remove cypress tree seedlings at road edge to avoid long-term maintenance issue.

Consider that cypress trees naturally grow to 40 ft high & wide.
