**Quarry Park Watershed Assessment and
Erosion Prevention Planning Project
San Mateo County, California**

PWA Report No. 181028503
April 2018

APPENDIX B | WATERSHED ASSESSMENT AND EROSION PREVENTION PLAN

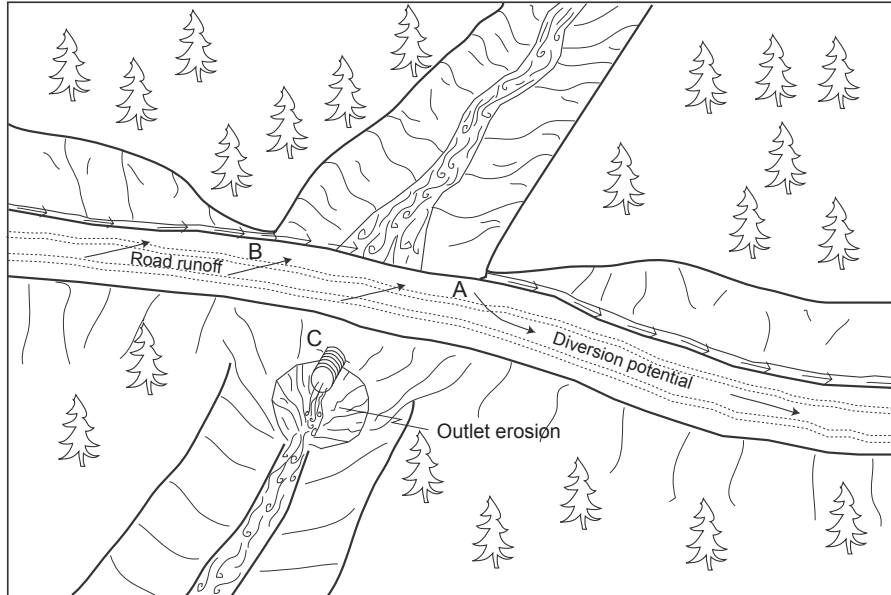
Problem condition (before)

- A - Diversion potential
- B - Road surface and ditch drain to stream
- C - Undersized culvert high in fill with outlet erosion

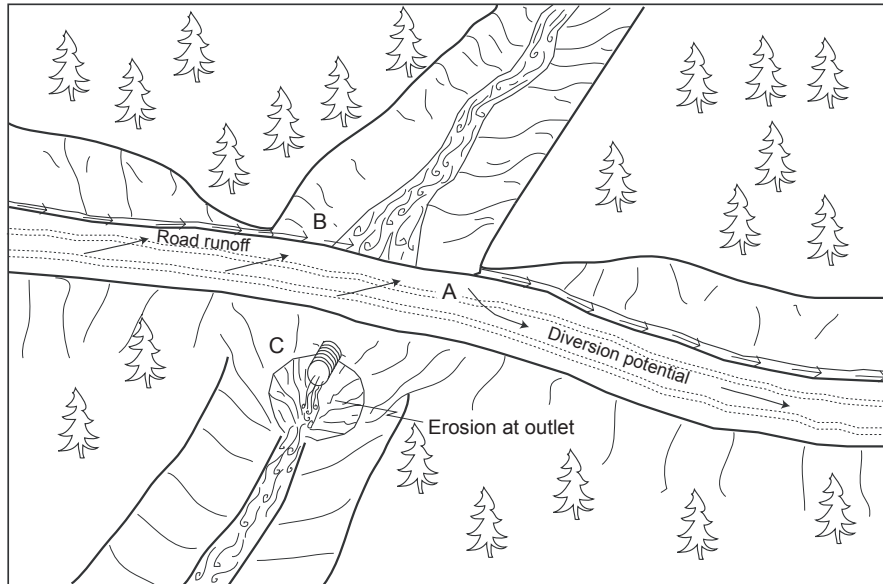
Problem condition (before)

- A - Diversion potential
- B - Road surface and ditch drain to stream
- C - Undersized culvert high in fill with outlet erosion
